The King's Train Carriage

Approaching the Conservation
of Larger Working Objects

Kine Elandria Bjørnsdatter Haugmåne
INSTITUTE FOR ARCHAEOLOGY, CONSERVATION AND
HISTORY AT THE UNIVERSITY OF OSLO 2019

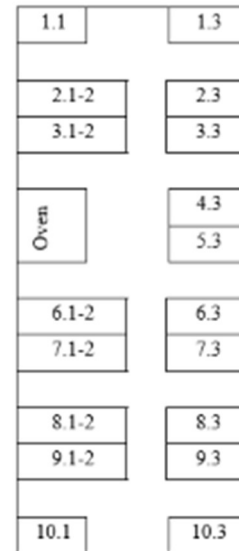
Figure 2-2: Layout of carriage, showing registration numbers.

Information about the seats' current condition, and the current rate of deterioration, was collected through three separate condition registrations which were carried out in the space of one year. One at the beginning of the project (8th of July 2017) one at the beginning of the Christmas running season (2nd of December 2017), and one after the Christmas season (5th of June 2018). Due to the level of deterioration it was decided that the registration should be limited to damage which pierced the fabric layer of the seat covers. In order to record data in a consistent manner each seat was assigned a number, and each hole in the seat cover was assigned a letter, then each hole was measured along its major and minor axis with a measuring tape. This made it possible to track damage over time, either as the expansion of already existing holes, as new holes appeared, or as previously separate holes merged into one. In cases where two holes merged the new hole was measured as one unit and referred to with both letters combined. During each registration, the seats and each individual hole were documented photographically. The full dataset can be found in appendix A.

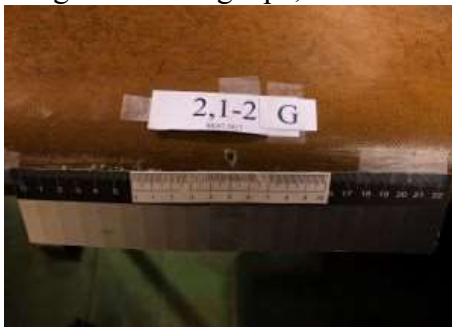
Figure 2-3: Photo from registration process
Photographer: Kine E. B. Haugmâne.

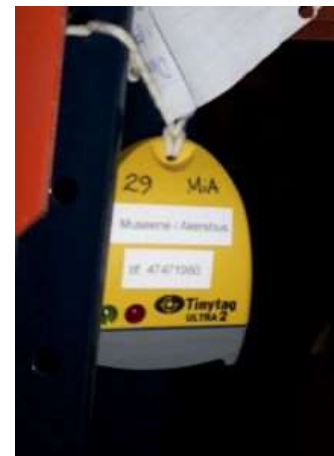
Figure 2-4: One of the dataloggers as it appeared during use.
Photographer: Kine E. B. Haugmâne

Two dataloggers of the Tiny Tag Ultra 2 type were used to track the changes in temperature and relative humidity that the seat covers were exposed to during use and storage. These devices are palm sized and battery operated, which made them easy to place in central locations without leaving them in public sight. They can also be left unattended for extended periods of time, only requiring occasional battery checks. Each unit measured temperature and relative humidity constantly and stored the resulting data in digital form. Once the measuring period had been completed, the data was extracted from the device using PC software.

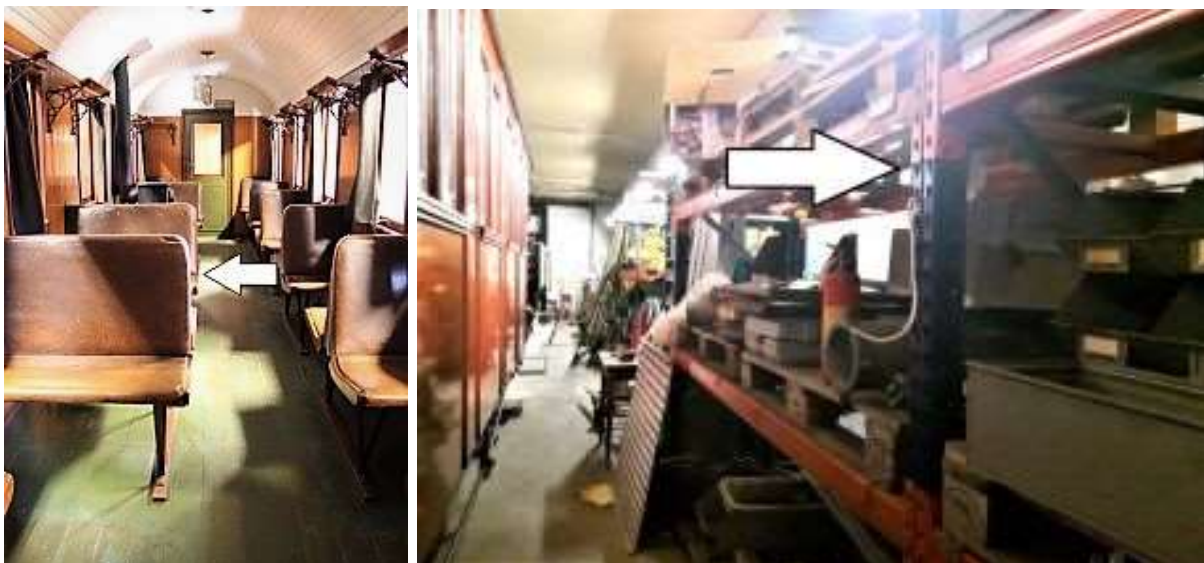
Figure 2-5: Placement of dataloggers in carriage and in storage hall.
Photographer: Kine E. B. Haugmâne

second datalogger. The other device, UHB2, was placed inside the carriage, hidden from view on the metal structure underneath a pair of seats, specifically 8,1-2 and 9-1,2. This location was chosen due to being near the centre of the carriage, but at the same time a fair distance from the oven which heats the carriage during use in the winter. The purpose of this logger was to document the conditions inside the carriage itself during storage and use. Small notes describing the purpose of the loggers were attached to each unit, in case someone uncovered them by accident.

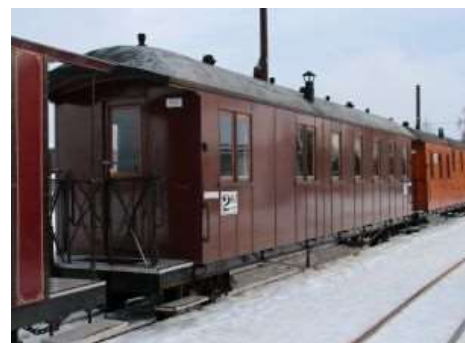
Figure 4-1: BCo3 as it looks today.
Photographer: Dorian Moon

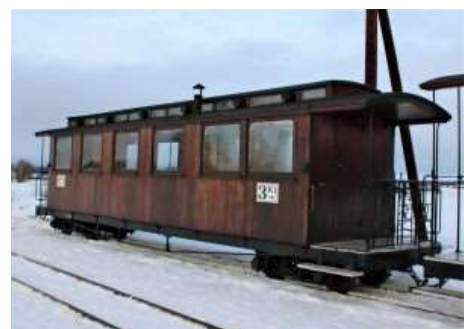
Figure 4-2: Co10 showing a skylight roof.
Photographer: Dorian Moon

These carriages were more extravagant than the older BC carriages already owned by the railway, with more space for passengers, and fashionable skylight roofs. This kind of roof has a lifted section in the middle, with little vertical windowpanes which let the daylight in from above. The carriages were also covered in painted metal plates, as opposed to the earlier teak cladding. In 1924 these carriages were updated in the railway's own workshop, and the

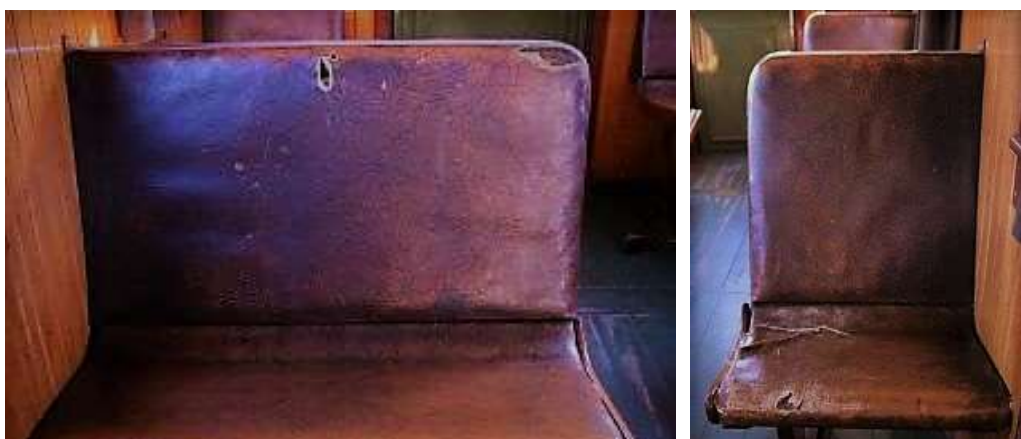
*Figure 4-3: Examples of the damage found on the seats.
Photographer: Kine E. B. Haugmâne*

have several holes and rifts, and in the worst affected areas the filling material has also disappeared. In short, they can be accurately described as heavily worn.

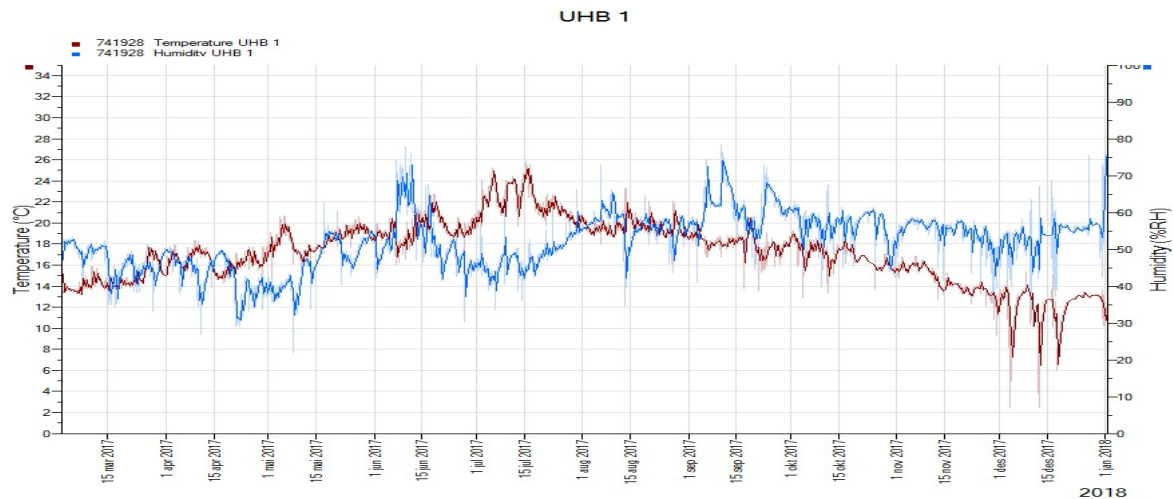
Figure 4-5: Humidity and temperature registered by the datalogger inside the storage hall.

The data recorded by the dataloggers can be found in the graphs "UHB 1" and "UHB2". As can be expected, the temperature data correlates with the climate in Sørumsand, being warmer in the summer than during winter. However, it is generally warmer in the hall than outside, as it is partially heated. Interestingly, there are deep spikes in the December months. These spikes represent days when the hall doors have been opened. In most cases, this was due to the carriage being in use (typically on Sundays). The minimum temperature recorded was about 2 degrees. This is important to note, as the outside temperatures would have been well below freezing during winter months. The current storage conditions thus prevent the carriage from being exposed to freezing conditions while in storage. The maximum

temperature recorded was about 32 degrees Celsius (in June), and the higher temperatures recorded during the summer months is likely due to the greenhouse effect of the sun shining into the hall and carriage through the windows. Relative humidity varied greatly. A maximum of close to 80% relative humidity and a minimum of 20% relative humidity was observed. In addition, large variations within a single day (especially during December) was

observed. Although no proof of condensation has been documented, this indicates a high possibility that condensation occurs. This hypothesis is supported by anecdotal evidence, but additional data would be required to confirm this.

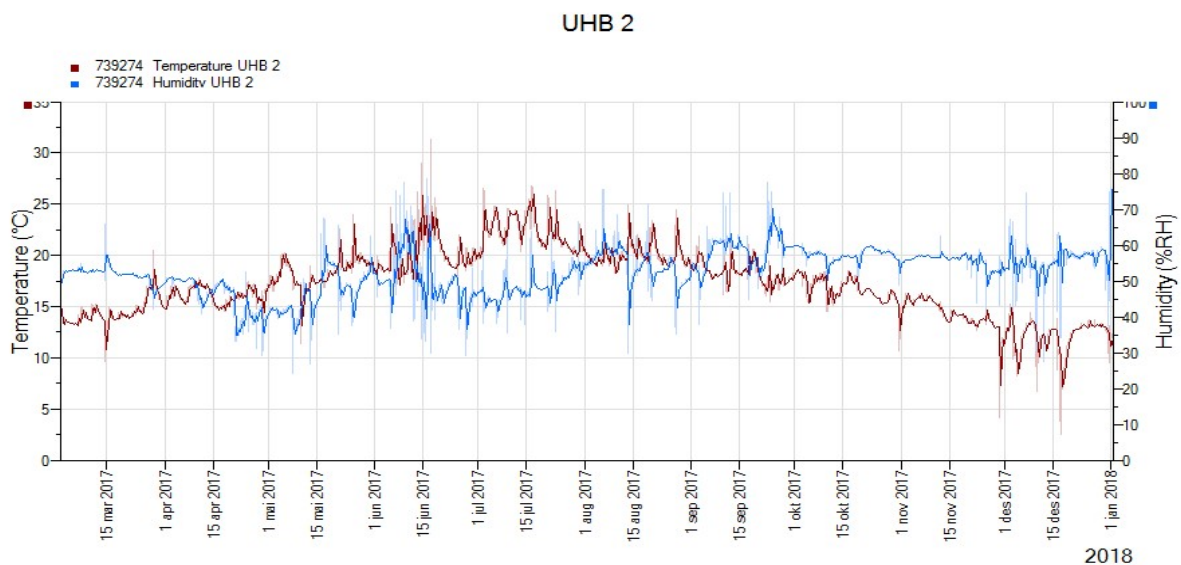
Figure 4-4: Humidity and temperature registered by the datalogger inside the carriage.

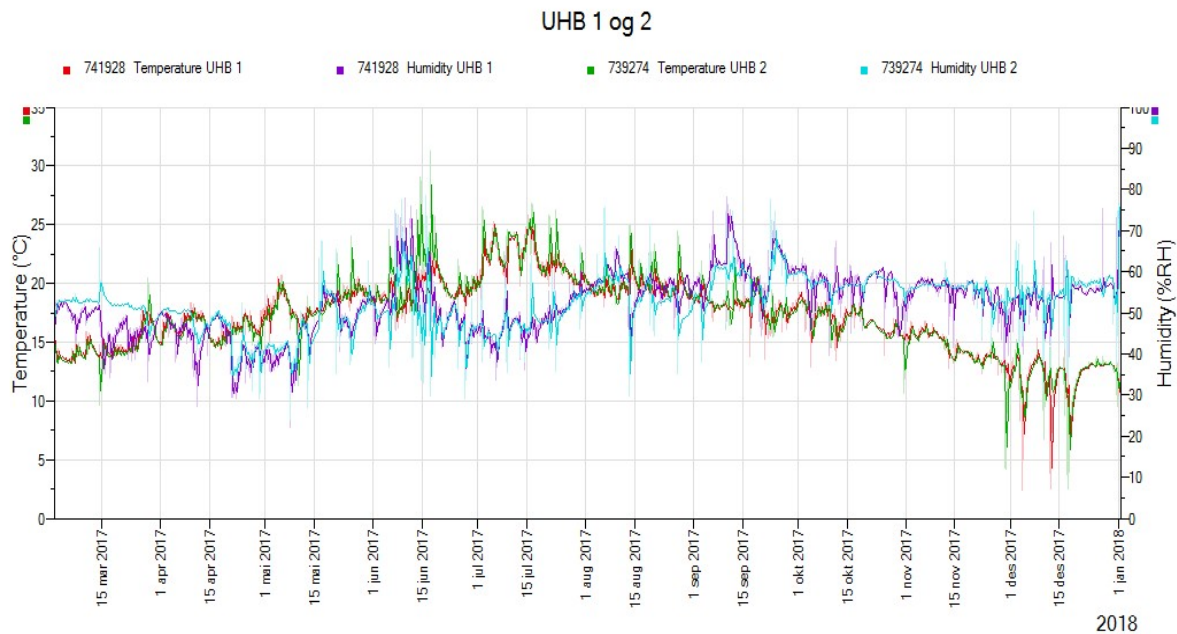
Figure 4-6: The data registered by UHB1 and UHB2 shown in comparison.

Figure “UHB 1 og 2” shows the data from the two dataloggers in comparison. The data mostly follows the same pattern. One of the reasons for this is of course that when the carriage is in storage the internal conditions of the carriage are affected by the conditions

inside the storage hall. However, there are some interesting differences between the graphs. This is especially pronounced during the winter months and appears to correspond to the carriage being in use during the winter season. Both due to the carriage to the outside, and due to the stoves being lit during its use. Larger versions of all three graphs can be found in appendix B.

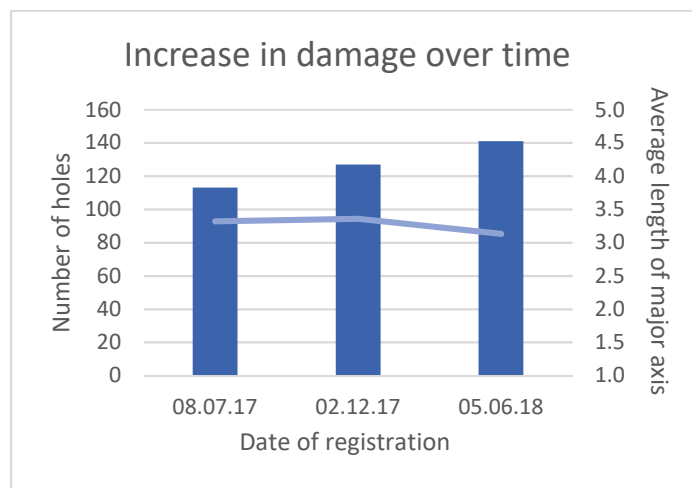
Figure 4-7: Number of holes and average length of major axis over time.

The most obvious metric is the number of holes registered in total. In cases where holes merged the original holes were counted individually. On the 8th of July 2017, there were 113 holes that pierced the fabric. This number increased to 127 by the 2nd of December 2017. Finally, by the 5th of June 2018, this number had increased to 141. This is a full 24,8% increase in just under one year of normal use. During this time the average size of the holes, as measured along their major axis did not change, but rather remained constant at approximately 3.3cm throughout the period. This means that the previous holes increased in

size fast enough to make up for the increase in of new and smaller holes.

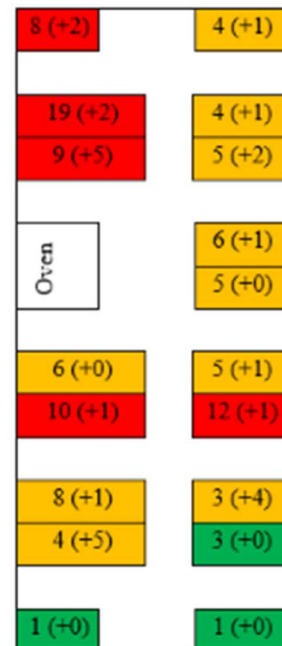
Figure 4-8: Holes per seat at first registration, with holes found later in parenthesis.

It is also interesting to note that the location of seats seems to have an impact on the amount of damage suffered, both before and during the registration period. This is illustrated in figure 4-8. In this figure the number of holes at the beginning of the period is shown as the main number. The number of new holes created during the period is shown inside the parenthesis. Finally, the seats are colour-coded by the total number of holes at the end of the final registration. Seats with less than 5 holes are green, seats with between 5 and 9 holes are yellow and seats with 10 or more are red. It's seems clear that the seats furthest from the entrance have sustained the least damage. This is likely due to passengers entering the carriage from the other side of the compartment. It is also interesting to note that the double seats appear to sustain more damage than the single seats. This might be due to these seats being more popular with parents traveling with small children. It also seems that the seats on the right side of the carriage sustain less damage than the seats to the left. This might be due to all these seats being single, the oven being on the other side of the carriage, or even these seats being exposed to less light during use and storage. More data would be needed in order to fully explain this difference.

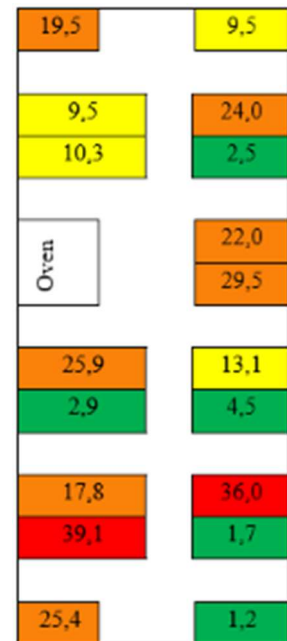
As the holes vary greatly in size and extent, it would be misleading to only compare the number of holes on each seat. Figure 4-9 shows the length of the largest hole on each seat, as measured along its major axis. Seats where the largest hole is smaller than 5cm are colour coded green, when the holes is between 5cm and 15cm it is coded yellow, holes between 15 and 30 are coded orange, while seats with larger holes are coded red. This representation shows a quite different story than the previous figure. Most of the larger numbers represent tears that extend along the side of the seats, where the fabric tends to crack. This effect does not seem to be correlated with the number of holes in each seat, underlining the importance of considering more than one metric.

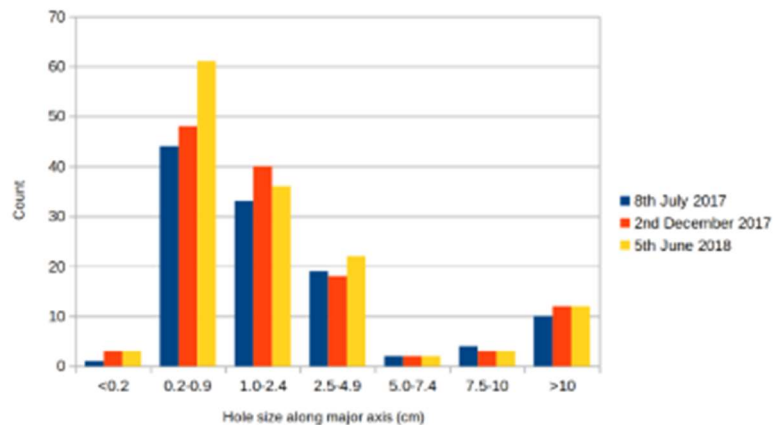
Figure 4-10 shows the numbers of holes by size, as measured along the major axis, and how this changed over time. There are many more small holes than large ones.

Figure 4-10: Number of holes of each size overtime, as measured along the major axis.

However, holes do not become smaller over time, and will increase in size unless treated. In some categories the number of holes goes down over time. For example, looking at holes larger than 10cm, the number has increased from 10 to 12 during the registration period. This is likely due to the existing holes growing larger, as well as previously separate holes merging as the damage expands. This is apparent from the corresponding decrease in the 7.5-10 category. This reduces the number of holes, while the actual severity of the damage clearly increases. It can also be seen that the number of holes smaller than 1.0cm increases sharply, from 45 to 64. This is due to new holes being formed during the period in question. Interestingly, in the 1.0 to 2.4 category, we see an increase from July 2017 to December 2017, which is followed by a

decline in June 2018. This change is due to holes that have migrated into the next category (2.5-4.9cm).

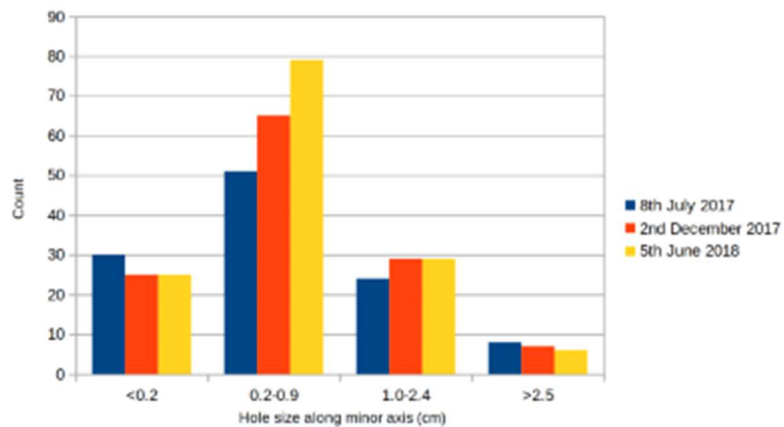
The holes, as measured along the minor axis, are shown in figure 4-11. This data is a bit harder to interpret, as what is considered the major and minor axis might change as the hole

Figure 4-11: Numbers of holes of each size over time, as measured along the major axis.

changes shape. However, the length of the minor axis is a good indication of the significance of the hole. The category “<0.2cm” contains both very small holes and quite large rifts, such as the ones found along the sides of the seats. Rifts typically expands only along the major axis, with relatively little expansion along the minor axis. The largest category is the “0.2-0.9cm”, which contains few rifts, but a substantial number of smaller holes. Unlike rifts, these holes tend to expand along both the major and the minor axis.

The last two categories represent significant damage to the fabric and tells us that a large portion of the underlying material is exposed, which in practice means that the padding underneath the seat cover is exposed to deterioration and possibly lost. It is obvious from some of the larger holes that this form of loss is a significant part of the deterioration process. Unfortunately, the larger a hole gets the faster it is likely to expand.

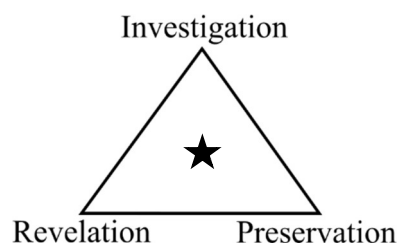
damage to the carriage, and the opportunity for a future conservation effort is left open, but the carriages will also continue to deteriorate at the present rate. It is possible to let the seats continue to deteriorate naturally, accepting the continued loss of original material and the carriage's deteriorating appearance as integral parts of the carriage's history and lifespan. However, this alternative does rely on understanding and accepting that the seat covers in the carriage will at some point no longer be able to serve in their current function.

Choosing not to interfere with the carriage or its use and storage conditions does not exclude the option of gathering further information. The deterioration processes which has caused the seats to be in their current condition will continue to take place. Monitoring this process over time can give a clearer picture of what causes the damage, and how the rate of deterioration can be slowed down. Together these two elements will make it possible to make

Figure 9-1: Doing nothing on the RIP-triangle.

a better decision about when and whether a potential conservation effort should be carried out, as well as identifying more useful preventive conservation options. In addition, this path would make it possible to spend more time researching and identifying suitable materials for this particular situation.

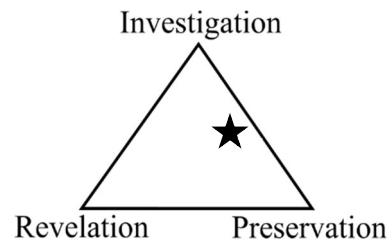
It is possible to attempt to reduce the amount of damage to the carriage by changing the way the carriage is used and stored. Just as with the previous option, following this path would not require any change to the carriage

Figure 9-2: Changes in use and storage on the RIP-triangle.

or intrusion into the original material. Neither would any new material need to be introduced. This option comes with two main alternative approaches. One alternative is to change how the carriage and seats are used, and the other is to change how the carriage is stored. These two options can also be adjusted and combined in several different ways.
